**FINAL SUMMARY REPORT OF
FUEL-DYNAMICS TESTS H2 AND E4**

ANL-76-16

Reactor Analysis and Safety Division

February 1976

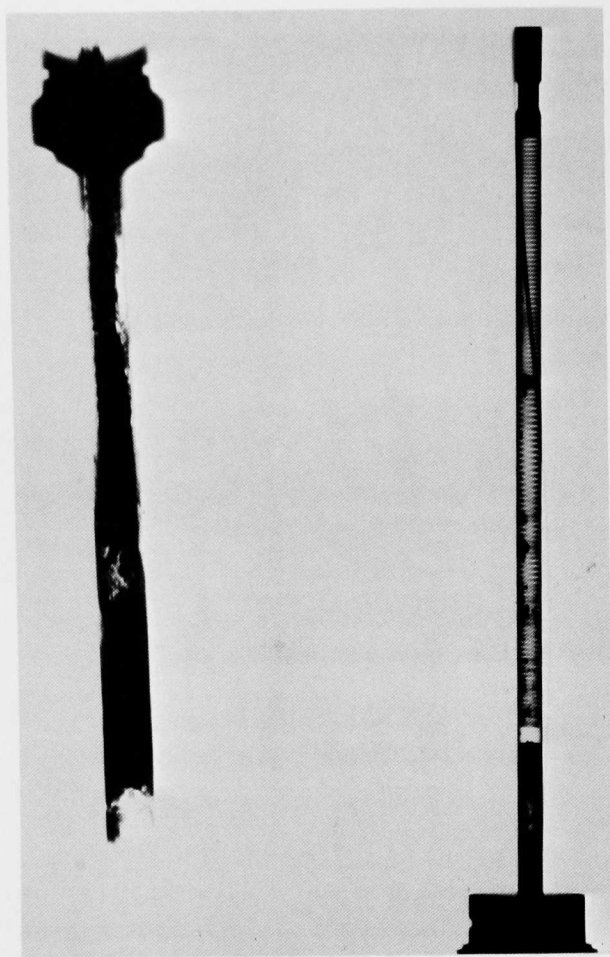
Fig. 60. X-radiograph of Upper Test Section Showing Remaining Upper Intact Section of Fuel Rod. Neg. No. MSD-164758.

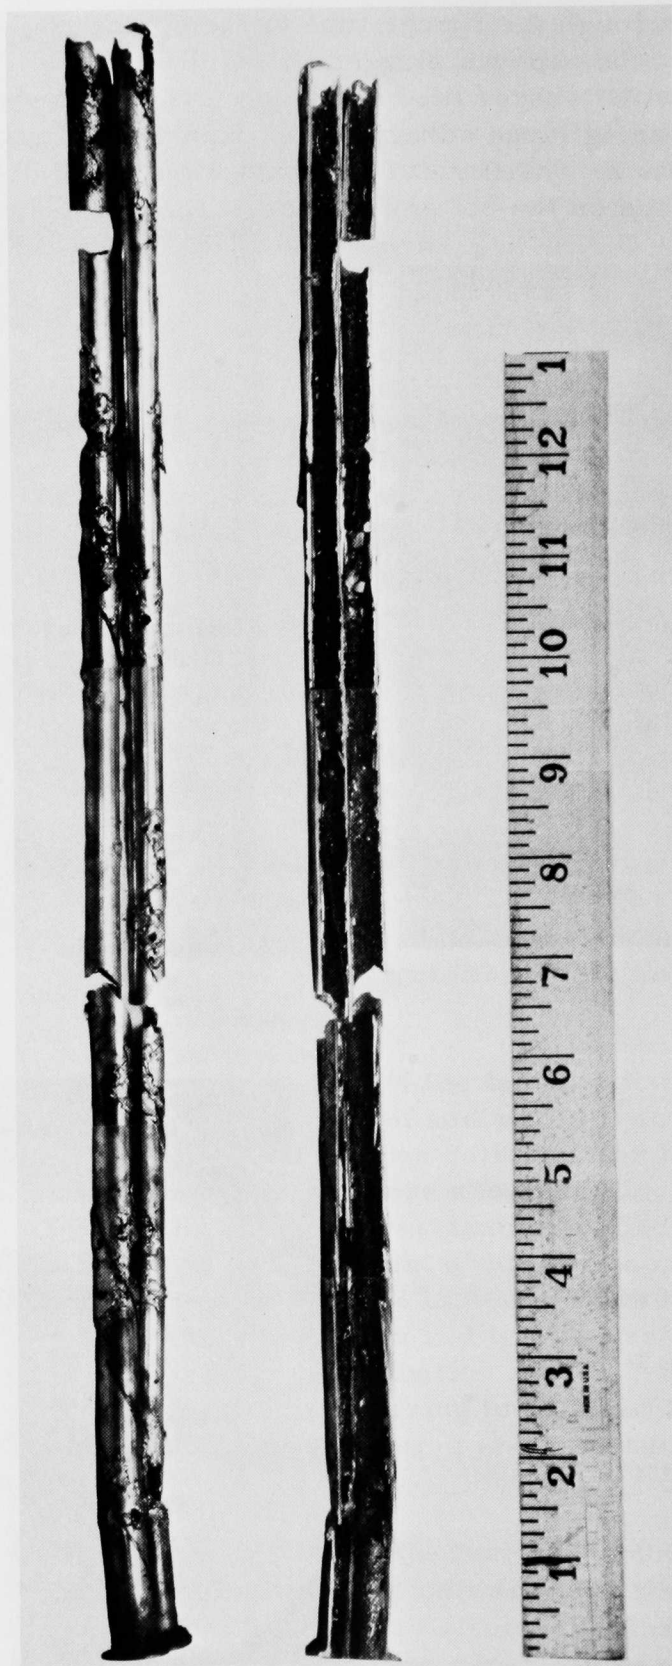
Fig. 63. Inside and Outside Views of Lower Portions of Inner Wall after Sodium Dissolution. Mag. 0.5X. Neg. No. MSD-165160.

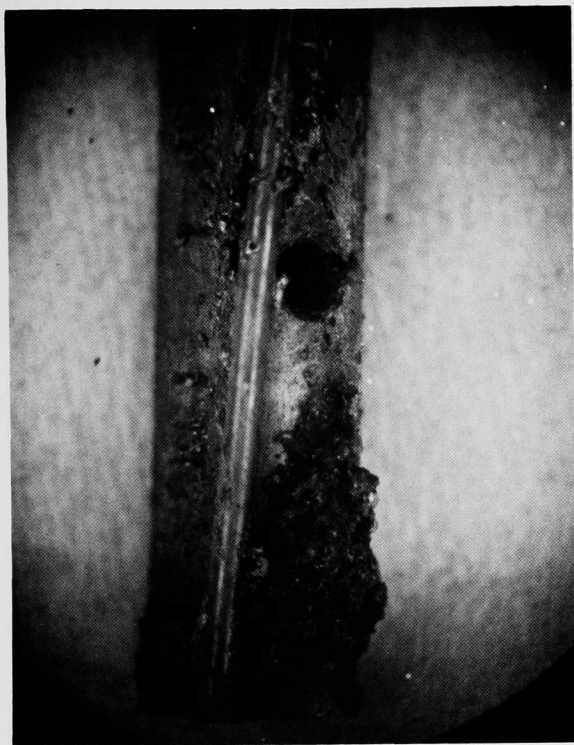
Fig. 64. Debris Solidified on Lower Portion of Lower End Plug. Mag. $\sim 5X$. Neg. No. MSD-165211.

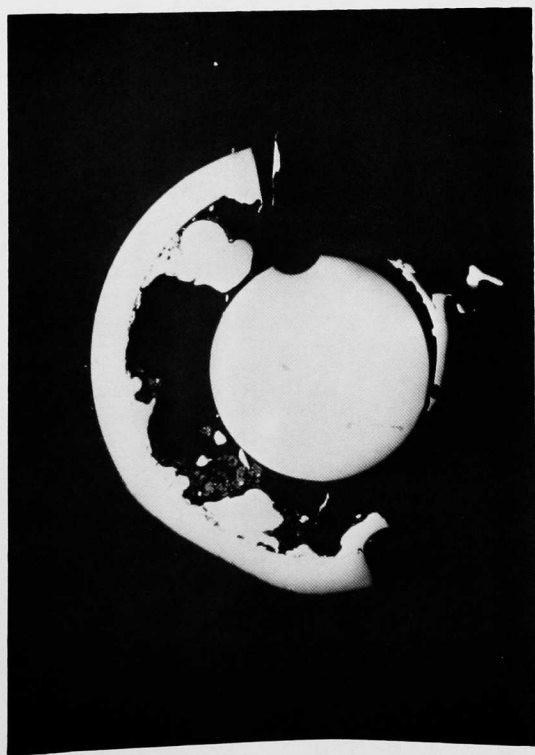
Fig. 65. Transverse Section through Lower End Plug and Inner Wall. Mag. $\sim 4.7X$. Neg. No. MSD-165035.

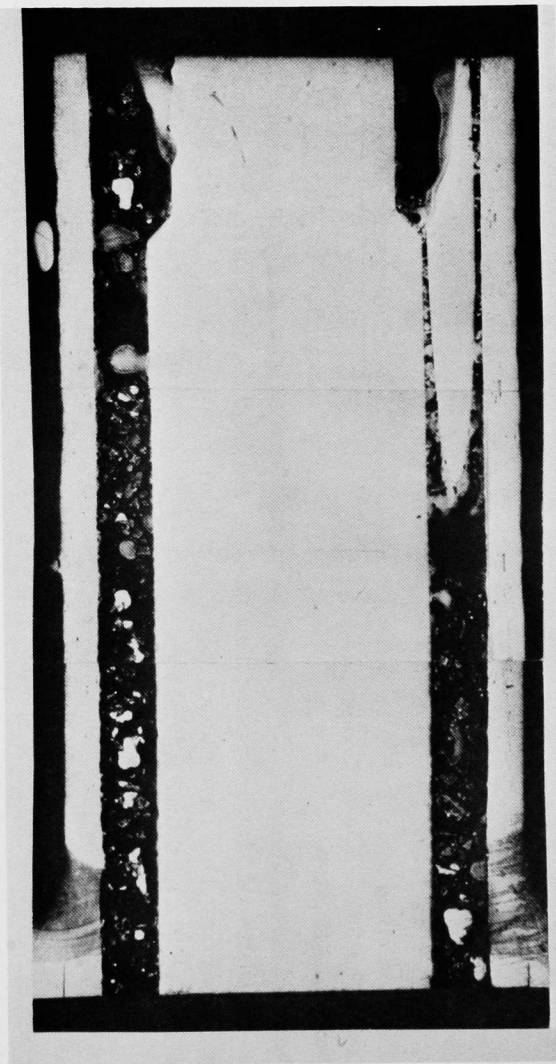
Fig. 66. Longitudinal Section through Lower End Plug and Inner Wall. Mag. $\sim 6.75X$. Neg. No. MSD-167417.

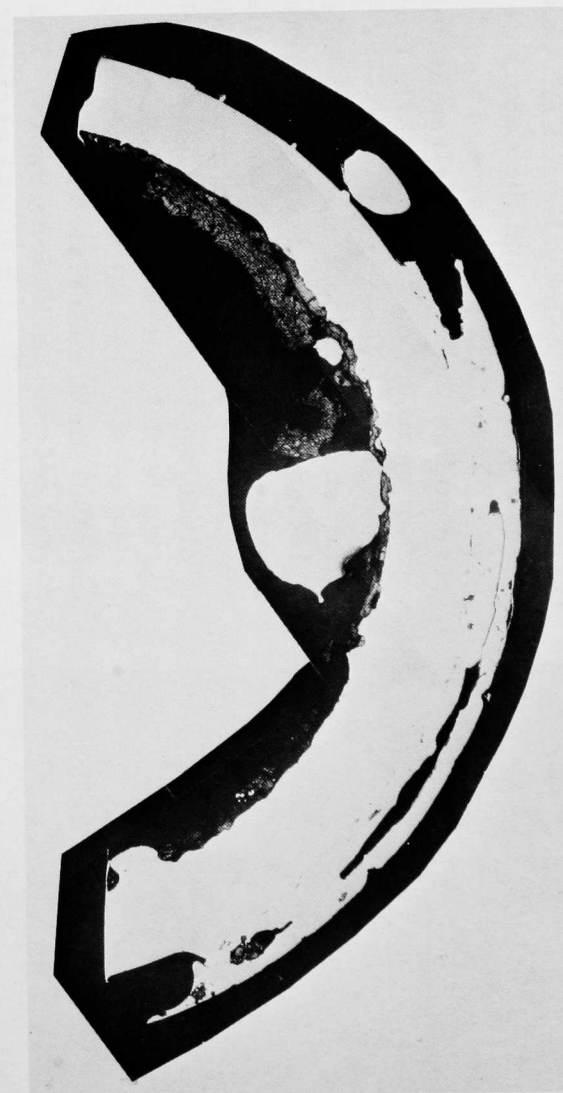
Fig. 67. Transverse Section of Inner Wall Just below Original Top of Fuel Column. Mag. $\sim 13.5X$. Neg. No. MSD-164898.

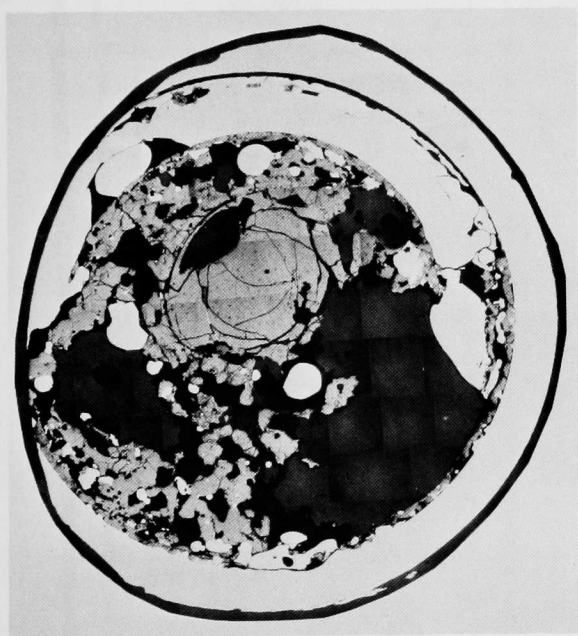
Fig. 68. Transverse Section near Flow Blockage 3.5 in. above Original Top of Fuel Column. Mag. $\sim 5.5X$. Neg. No. MSD-164897.

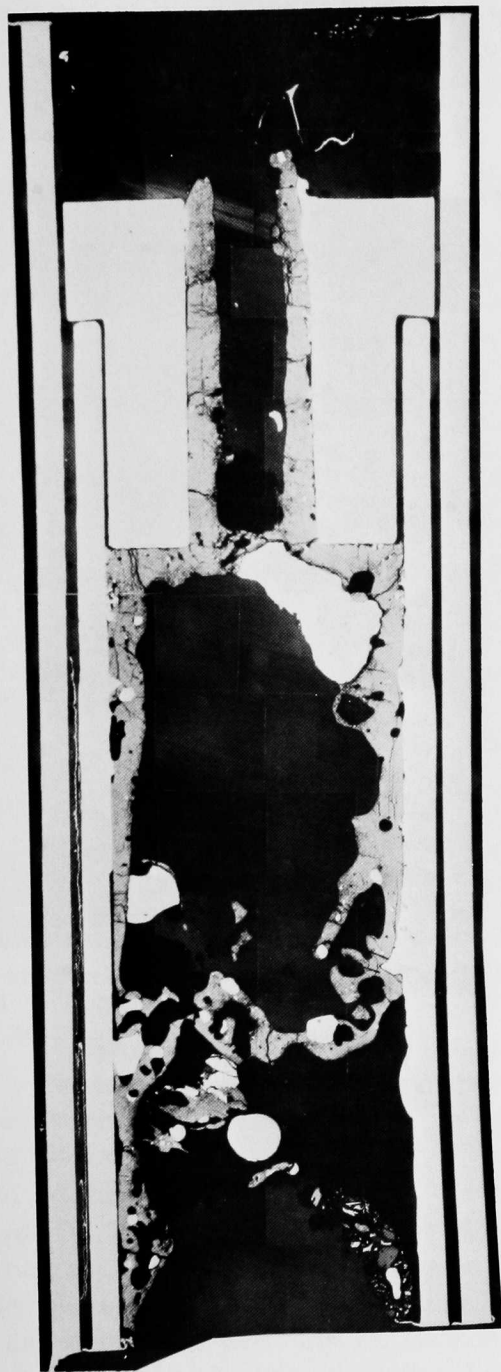
Figure 71 shows the longitudinal section of the upper plenum region containing the spacer tube and cap, against which fuel and cladding have

Fig. 71. Longitudinal Section of Plenum, Showing Spacer Tube and Cap. Mag. $\sim 10\times$. Neg. No. MSD-164901.

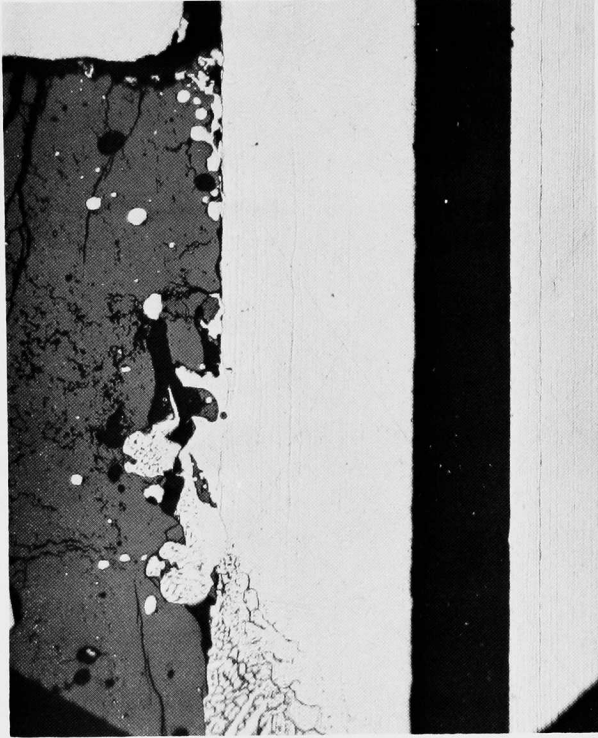
Fig. 72. Fuel and Cladding Impacted on Spacer Cap. Mag. 70X. Neg. No. MSD-164891.

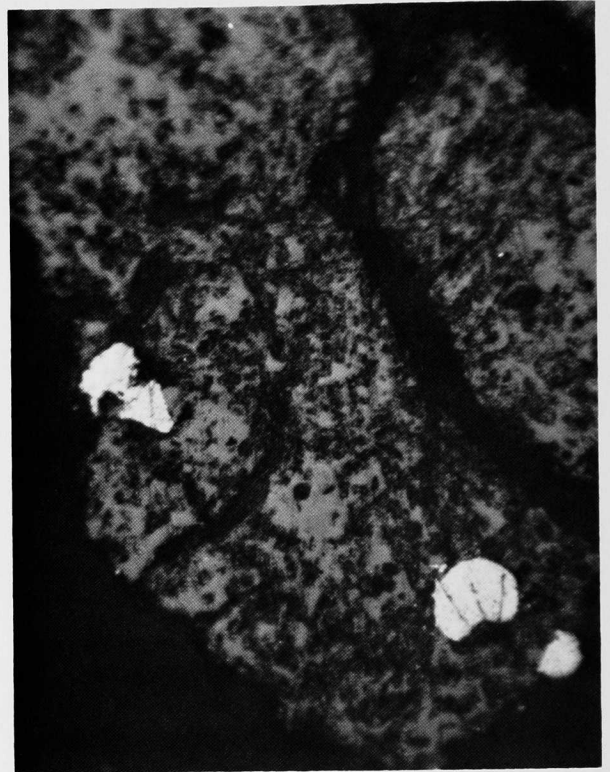
Fig. 73. Fuel Particles Collected From Test Section during Disassembly. Mag. 350X. Neg. No. MSD-165218.

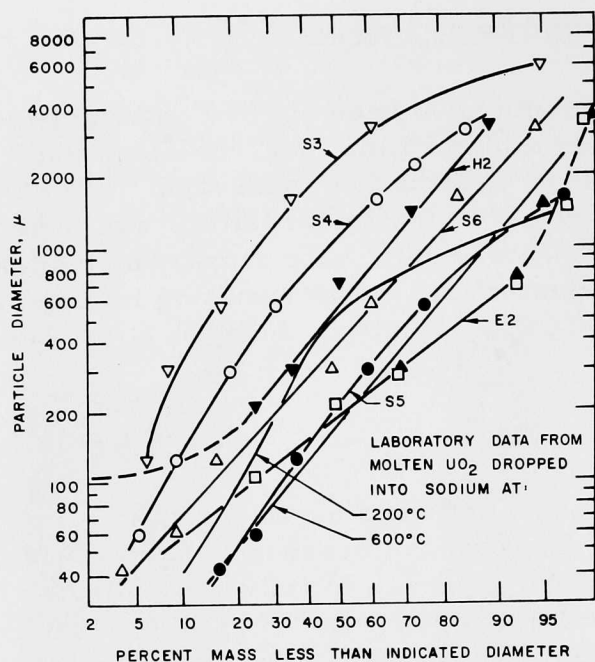
Fig. 74. Particle-size Distributions for Zero-burnup Failure Test

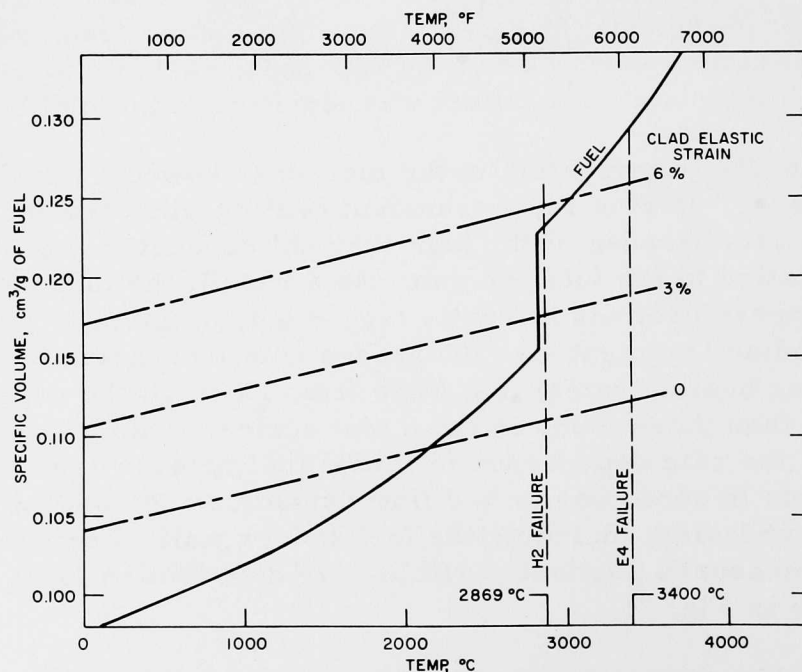
Fig. 75. Specific Volume of Fuel Pellets as a Function of Temperature. The volume that can be contained by the cladding at 0, 3, and 6% strain is shown as the dashed line. The step increase in specific volume at 2840°C is due to the change from solid to liquid.
